Trouble Shooting Guidelines

PRINCIPLE OF EXHAUST GAS TURBOCHARGER

TC Complaint diagnosis

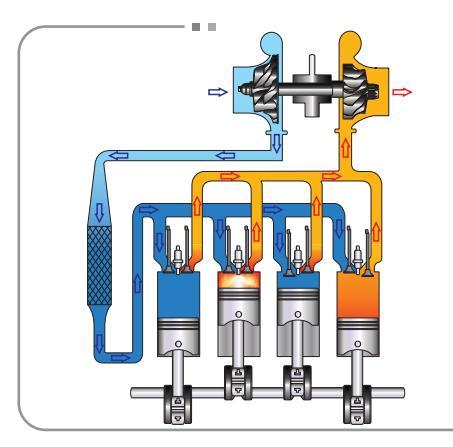
In a turbocharged engine, the exhaust gas which would normally be wasted, is used to drive a turbine. The turbine in turn drives a compressor, which draws in air and compresses it and supplies it at a higher pressure to the engine. Due to higher air availability and by supplying more fuel, engine power output can be increased. Higher air availability helps in better combustion, thus leading to reduced fuel consumption and less emission.

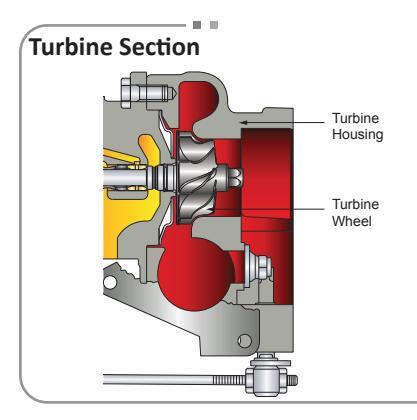
Turbocharger (TC) primarily comprises of a compressor section and a turbine section. The turbine and compressor wheels are mounted on a common shaft, hence they rotate as a single unit. This sub-assembly is known as the rotor assembly. The rotor assembly is supported by journals placed inside the central housing.

Turbine section consists of the turbine wheel and turbine housing. The pressure energy available in the exhaust gases is converted into Kinetic energy by the turbine housing and is used for rotating the turbine wheel.

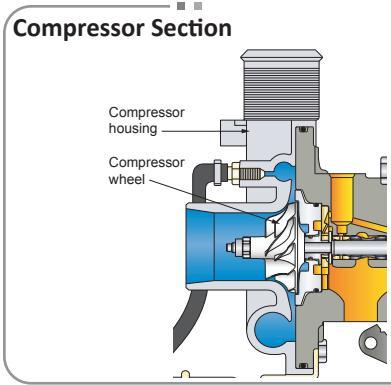
The compressor consists of the compressor wheel and compressor housing. The compressor wheel draws in air axially and delivers it radially at a higher velocity. The compressor housing converts higher velocity air into higher pressure.

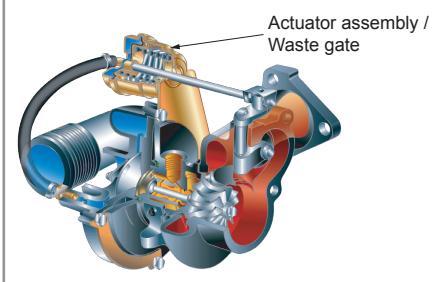
Waste Gated Turbocharger

For reasons of improved TC response, turbine housing with a smaller cross sectional area is chosen so that sufficient boost pressure is available at lower engine speeds. Part of the exhaust gas is by-passed once the required boost pressure is reached. This is achieved by

opening a valve, operated by a spring loaded diaphragm (actuator assembly) with the help of boost pressure available in the compressor housing or with the help of external vacuum supply.

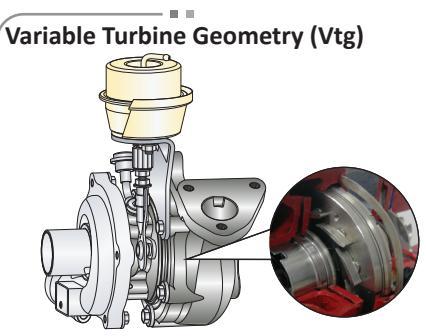
The turbine flow cross-section varies in accordance with the engine ECU demand by variable guide vanes placed in the exhaust gas flow area of the turbine housing. As a result of continuous turbine cross section adjustment to the engine airflow requirements, high engine

torque at low speeds and with adequate control strategy ensures a significant improvement of dynamic performance of vehicle. Guide vane control is mostly electronic through a vacuum regulated actuator.

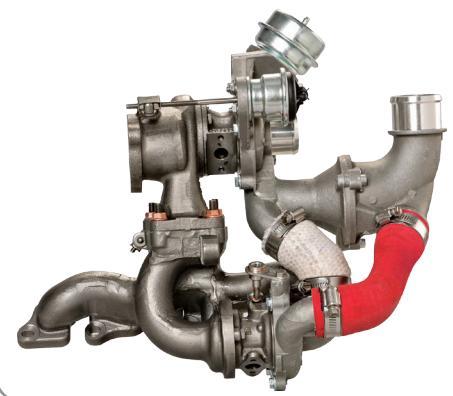
R2s Turbocharger

Regulated two stage turbocharger (R2S). This system uses one low pressure turbocharger and one high pressure turbocharger i.e. two turbochargers for one engine. This technology helps in increasing the engine's specific power output (power to weight ratio) and also helps in downsizing the engine while meeting the performance requirement.

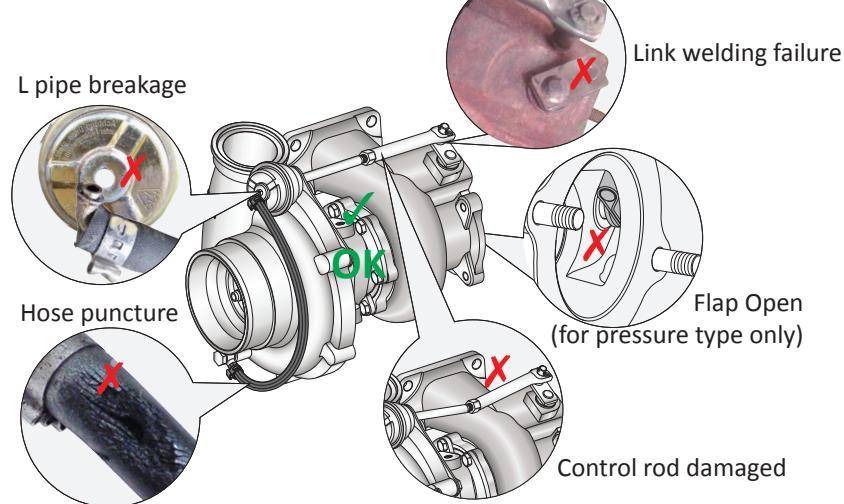
Check the TC actuator assembly for its proper functioning i.e. check for damages, tampering, loose or open connections.

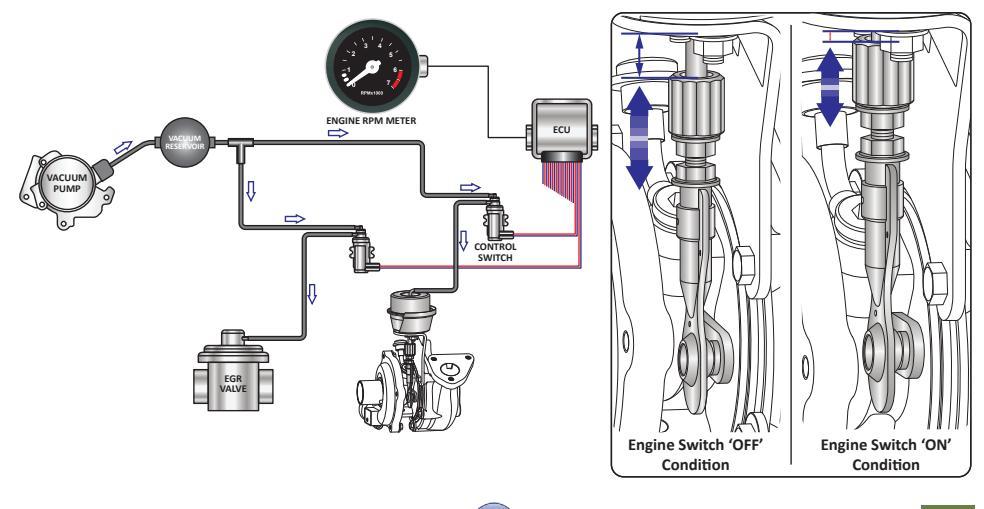
VTG TC VACUUM ACTUATOR CHECKING PROCEDURE

The normal working condition:

When the engine is switched off, TC actuator will be in OPEN condition i.e. Actuator control rod length will be maximum.

When the engine is switched-on (while engine in running condition), TC actuator control rod will be in closed condition i.e. Actuator control rod length will be minimum.

During the engine operation the TC actuator control rod moves freely without restriction.

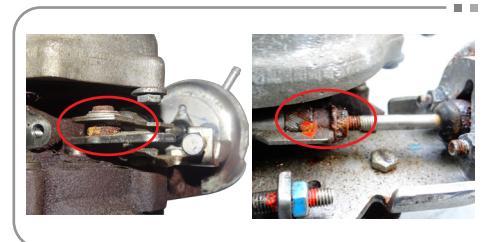
Check if the actuator control rod is proper (ensure that it is not tampered), the adjusting nuts are in place, the control rod is not damaged, rusted, excessively worn-out.

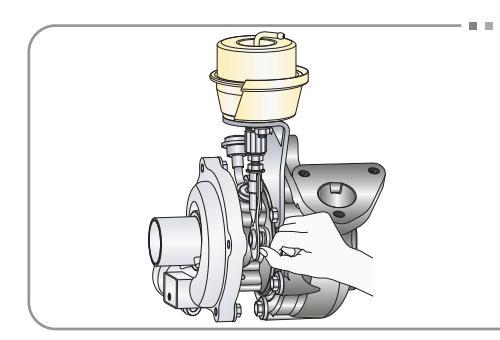
Move the control rod with hand confirm its movement is free.

Remarks: If all checks on vehicle found O.K and the TC actuator operation is not O.K i.e. the actuator control rod does not move up when the engine is switched-on and moves down when the engine is switched-off OR the TC actuator control rod movement is not free - Replace the TC.

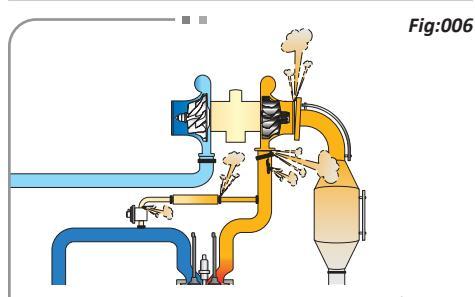
- Damaged gaskets, Improper / leaky joints due to cracks, Misalignment / damaged connections (inlet, outlet & EGR)
- ✓ Correct leaks & misalignments, Correct / replace damaged parts

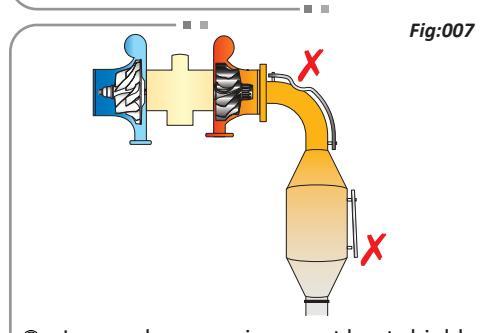
- Loose, damages, incorrect heat shields
 Replace with correct parts & ensure its proper fitment
- Defective silencer / exhaust brake valve
- $\ensuremath{\boxdot}$ Correct / replace the defective parts

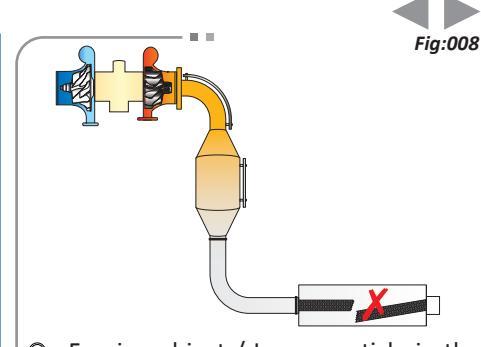
Foreign object / Loose particle in the exhaust system

☑ Remove particle

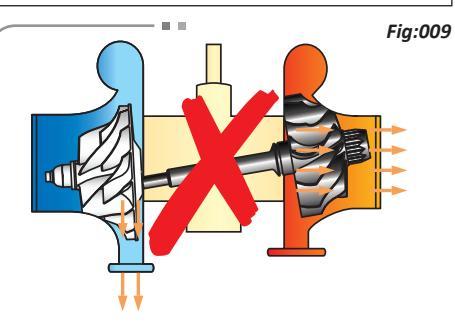
Fig:010

O Defective TC✓ Replace the TC

- Wheels rubbing with excessive dust/ carbon
- ☑ Replace the TC

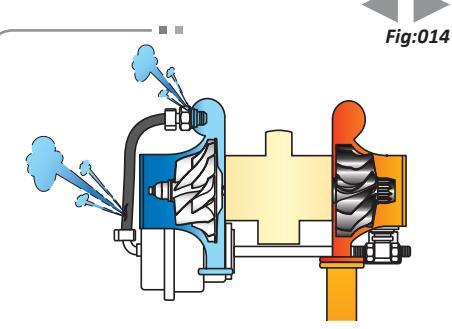
Air leakage from boost pressure pipe connections

☑ Correct the leakage

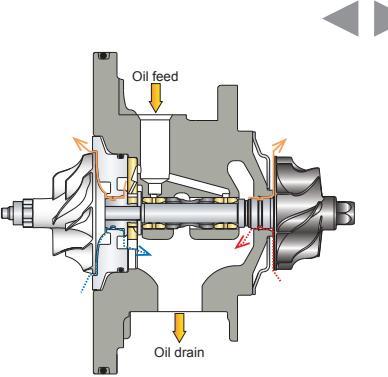
TC sealing principle

Turbocharger does not have seals like engine seals, sealing is realized by piston rings (similar to engine piston rings) on both compressor & turbine side. The purpose of this sealing is to prevent oil leakage from bearing housing towards the compressor and turbine housings. TC Sealing system works on pressure differential. The design principle of this

piston ring sealing allows leakages there is a clearance available between rotating parts & stationary piston rings. Under normal engine operating conditions, there is a gas leakage from the turbine & compress housings into the bearing housing and consequently to the engine blow-by system.

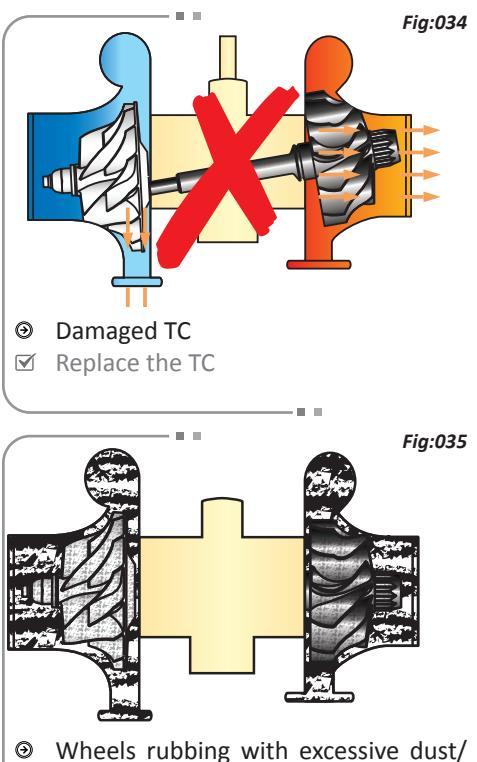
Wheels rubbing with excessive dust/ carbon

Replace the TC

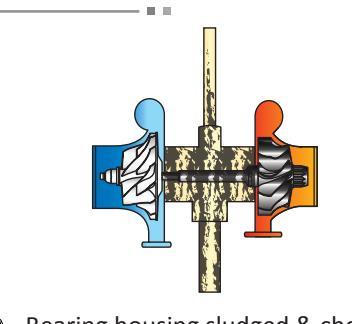
- Bearing housing sludged & choked
- Replace the TC

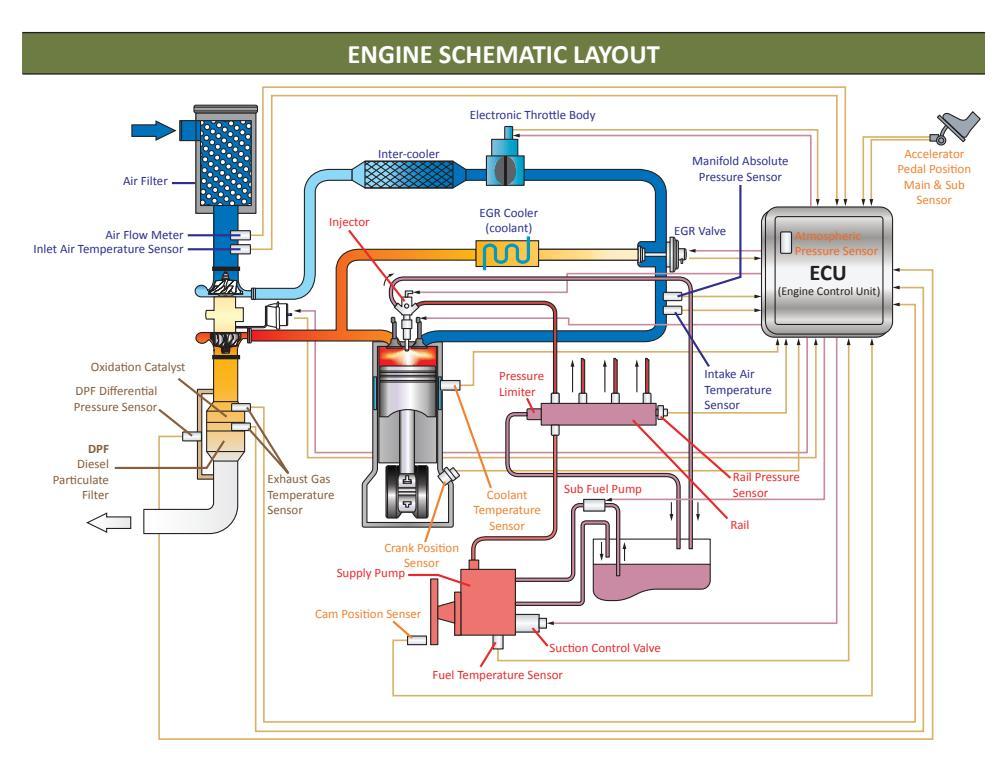
The above schematic diagram provides the details of additional components to an engine and its integration. Since the engine & the components are interconnected and are controlled by a single ECU. Proper functioning of each component is a must for engine to perform to its designed function.

Before suspecting the TC for performance it would be appropriate to ensure proper functioning of all the other components of an engine. It is advisable to use the recommended engine diagnostic tool to identify the exact cause of complaint.

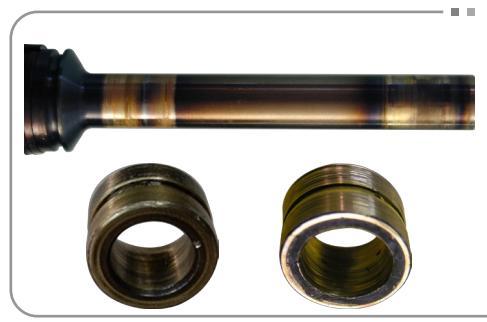
Complaint: TC Damage

Observations: Blue colour formation on the shaft journal area. Seizure / excessive wear on the journals

Causes: Lack of oil supply

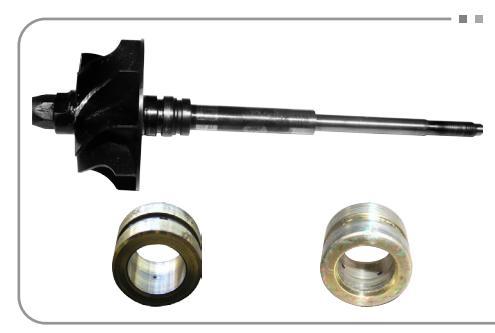
Complaint: TC Damage

Observations: Journal oil holes closed partially. Discolouration / glazing marks on shaft journal contact area

Causes: Insufficient oil supply / Low oil pressure

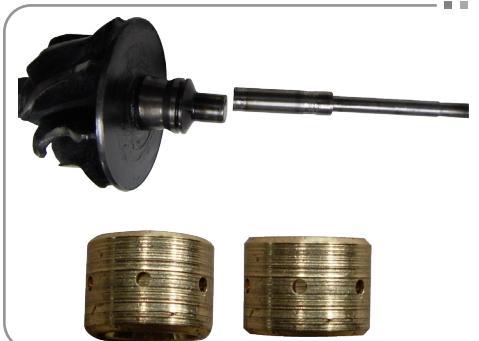
Complaint: TC Damage

Observations: Wear marks on turbine shaft journal area, journals, and bearing housing bore area

Causes: Bad oil condition (dirt in oil)

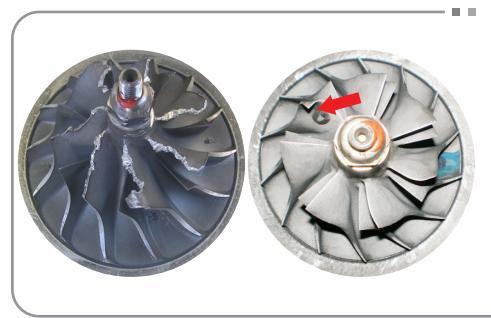
Complaint: TC Damage Observations: Compressor wheel damaged at entry area

Causes: Dust or dirt or metallic particles like nut/bolt/screws entry into compressor inlet

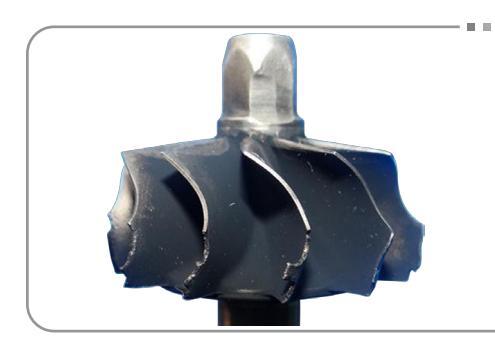
Complaint: TC Damage

Observations: Turbine wheel blades damaged at gas entry area

Causes: Broken valves, valve seats, core sand or any loose particle entry into Turbine housing

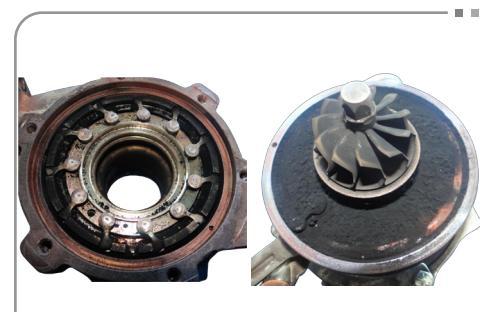
Complaint: Poor Pickup - Actuator Control Rod Movement Not OK.

Observations: Excessive carbon deposit observed in the Turbine housing cartridge area.

Cartridge not free movement.

Causes: Poor fuel quality / Operating conditions
